HAZARDOUS MATERIALS SURVEYS

**NATIONAL OCEANIC & ATMOSPHERIC
ADMINISTRATION**

PRIBILOF FACILITIES

- **WASH HOUSE ABOVE THE SEALING PLANT**
- **COTTAGE C**

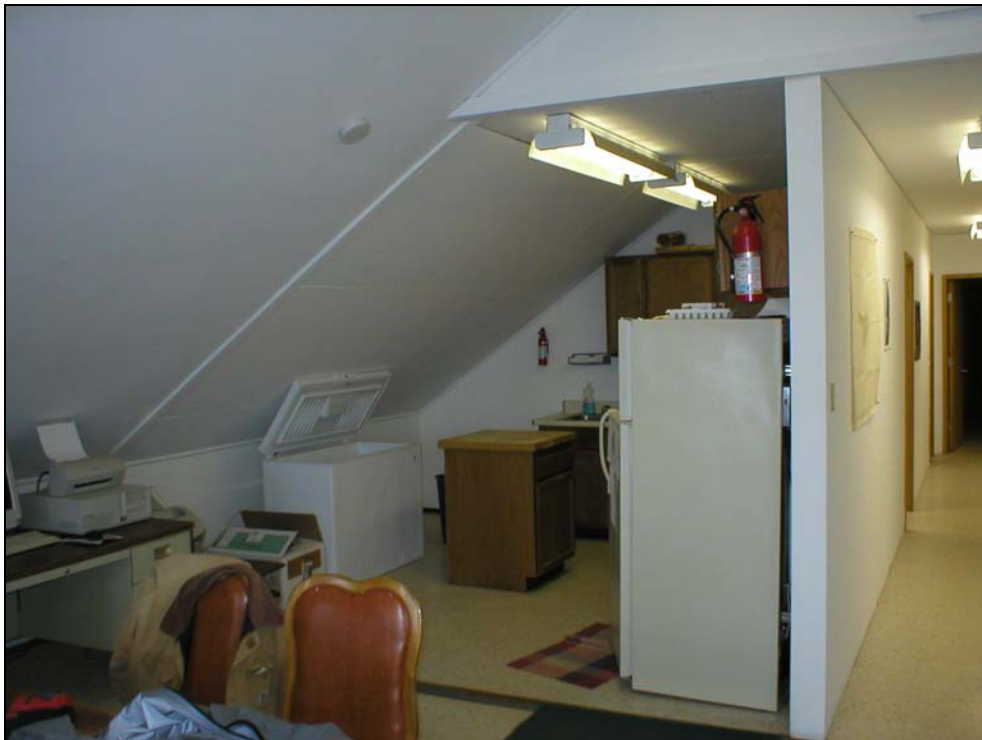
The sprayed-on undercoating on the stainless steel sink in the kitchen was found to be asbestos containing. The material was in good condition and was considered non-friable.

Photo 2: White Sink Undercoating (5% Chrysotile)

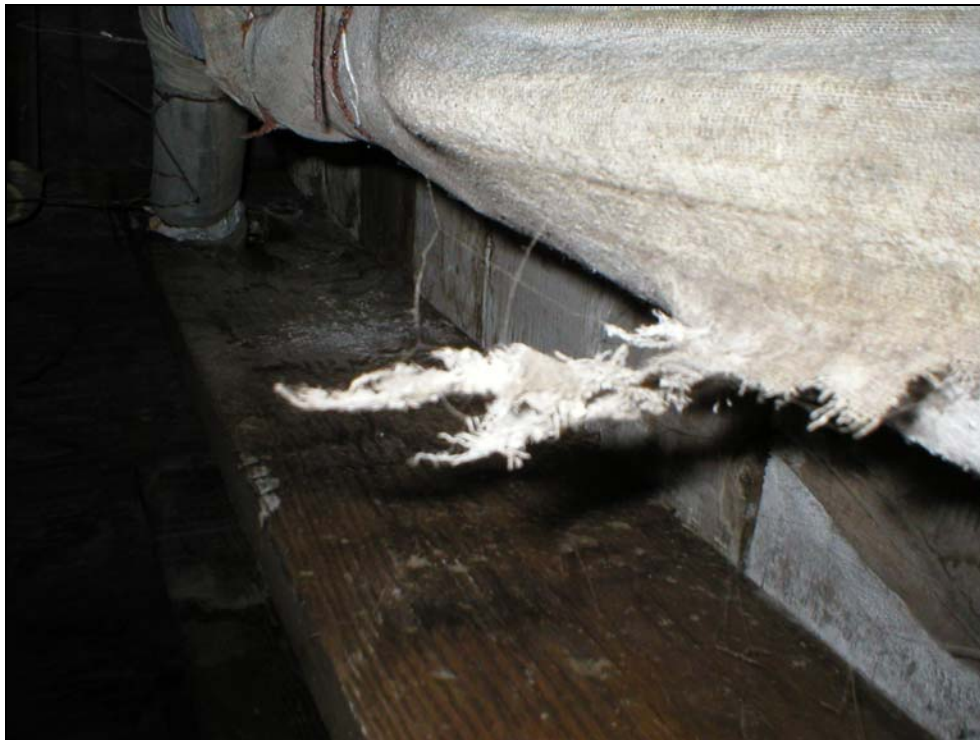
A small amount of Aircell pipe insulation was discovered in a small crawl space west of the western stairwell in the basement. The area was inaccessible and therefore the insulation was not removed during previous abatement efforts. It is possible that additional asbestos-containing pipe insulation is still inside plumbing walls. The material was in fair condition and is considered friable.

Photo 2: Aircell Insulation West of W stairwell in basement crawl space
